WT-65

This volume is the report of a test program to measure under carefully controlled conditions on the ground the effects of an atomic bomb on aircraft and missile structures. Some measurements of the blast and thermal phenomena peculiar to the USAF problem are included.

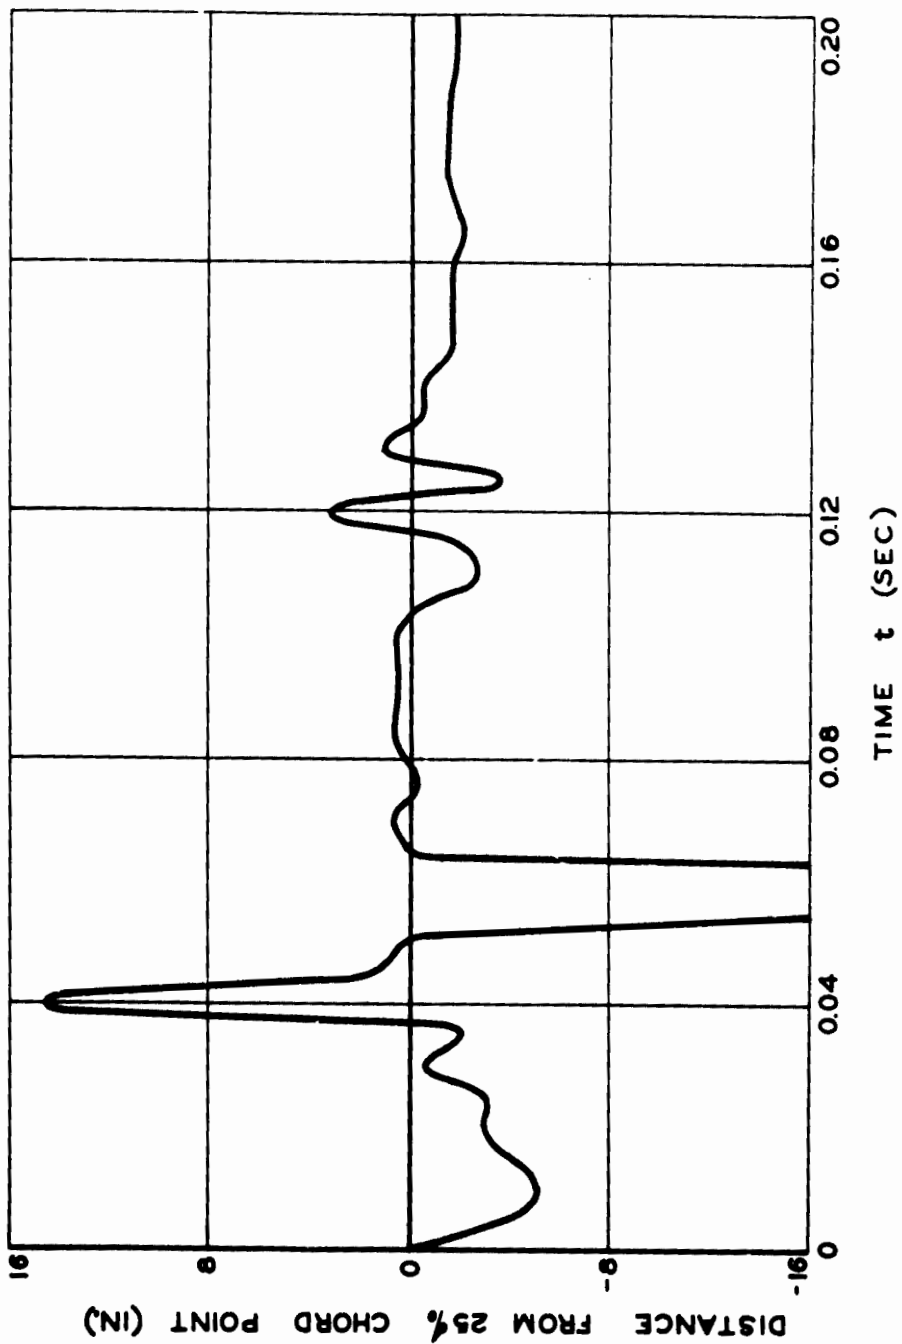
Fig. 5.28 Variation of Center-of-pressure Distance from the 25 Per Cent Chord Point with Time, Obtained from Differential-pressure Measurements for Rigid Wing 102. The angle of incidence was  $9^\circ$ , and the range was 4,020 ft, Engelb.

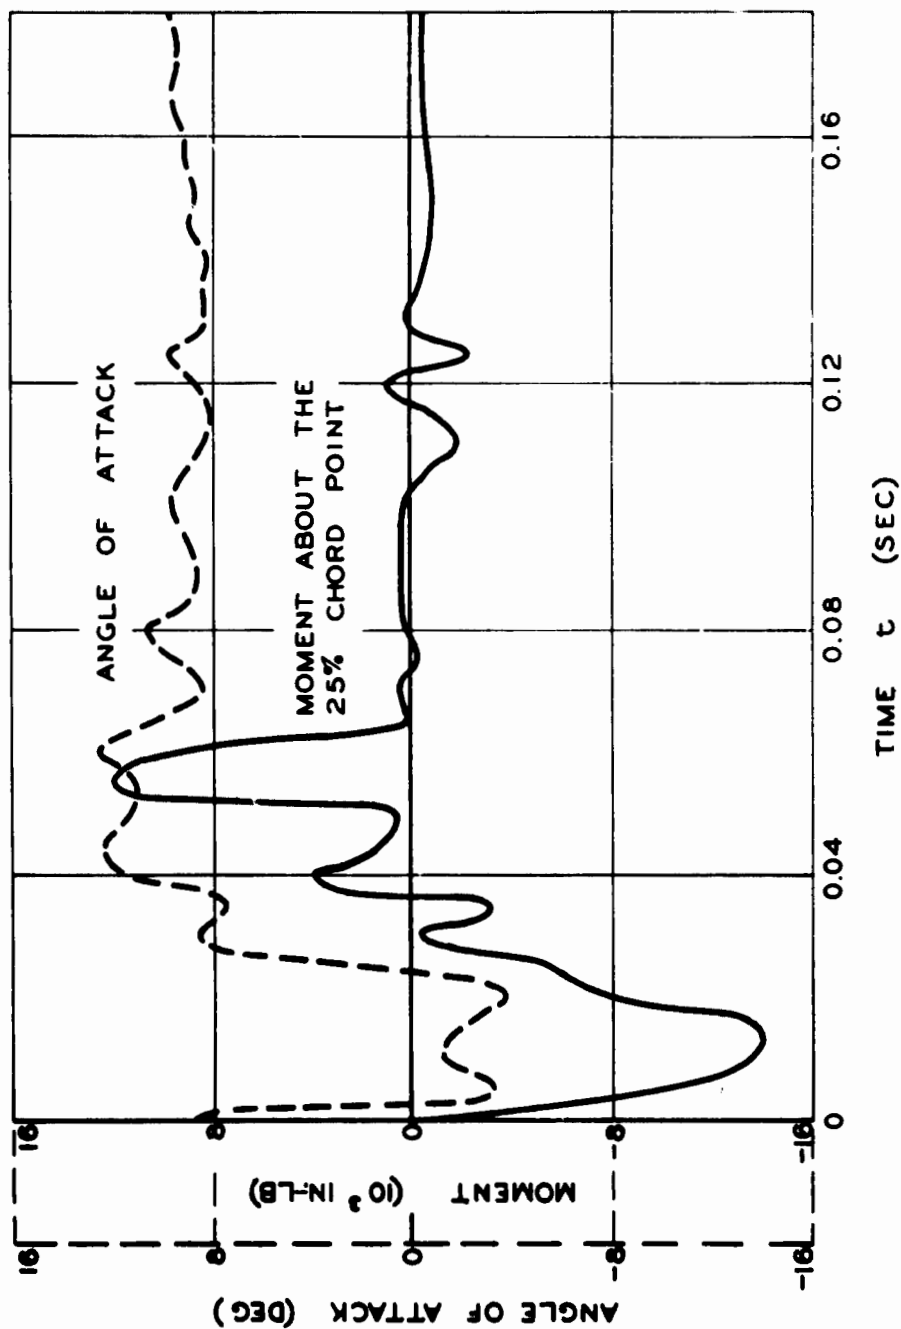
Fig. 5.29 Variation of Moment about the 25 Per Cent Chord with Time, Compared to the Variation of Angle of Attack for Rigid Wing 102. The angle of incidence was  $9^\circ$ , and the range was 4,020 ft, Engebli.

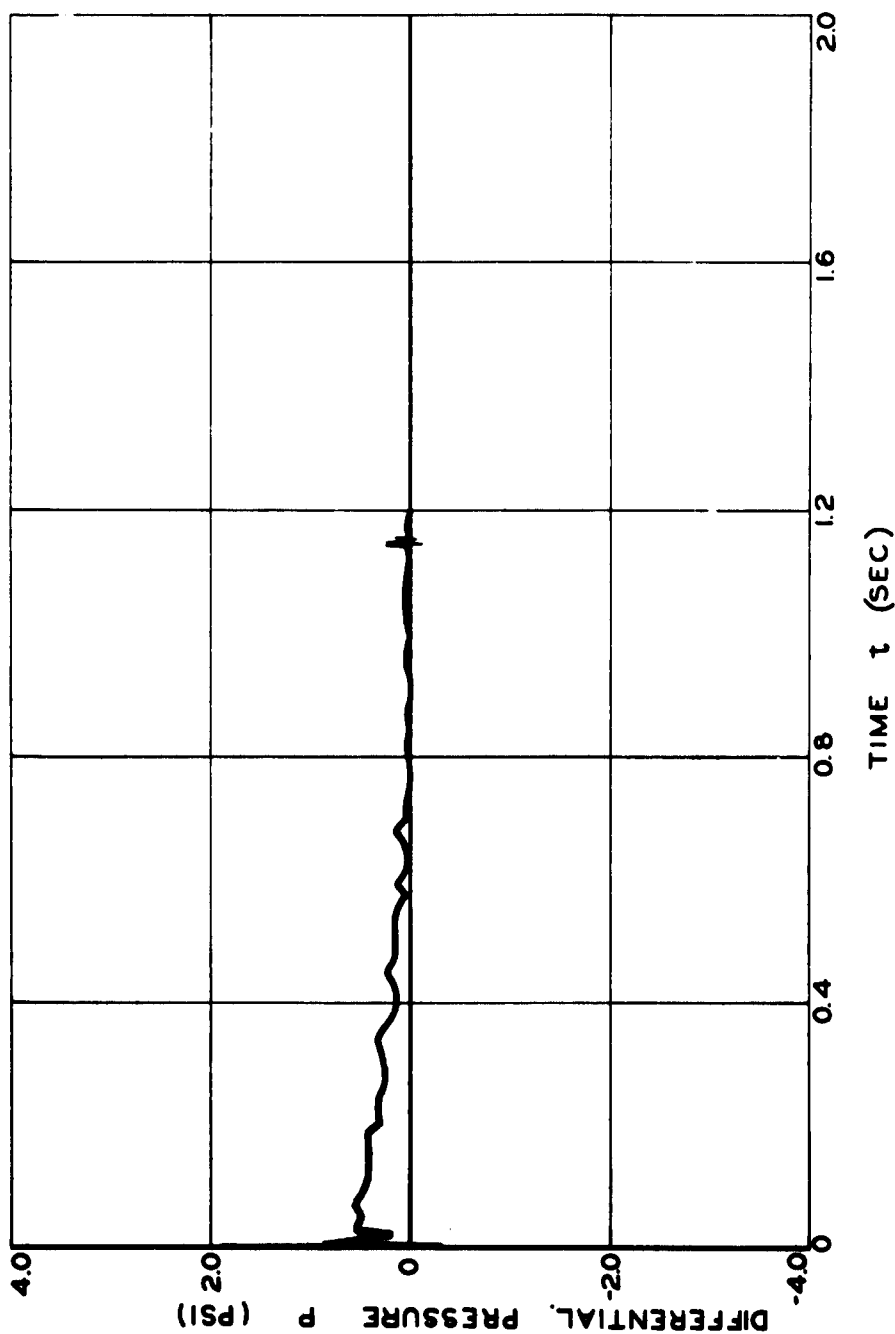
Fig. 5.30 Variation of Differential Pressure with Time at 10 Per Cent Chord of Rigid Wing 202. The angle of incidence was  $9^\circ$ , and the range was 6,878 ft, Muzin, indicating abrupt pressure variations 1,150 msec after passage of blast front.

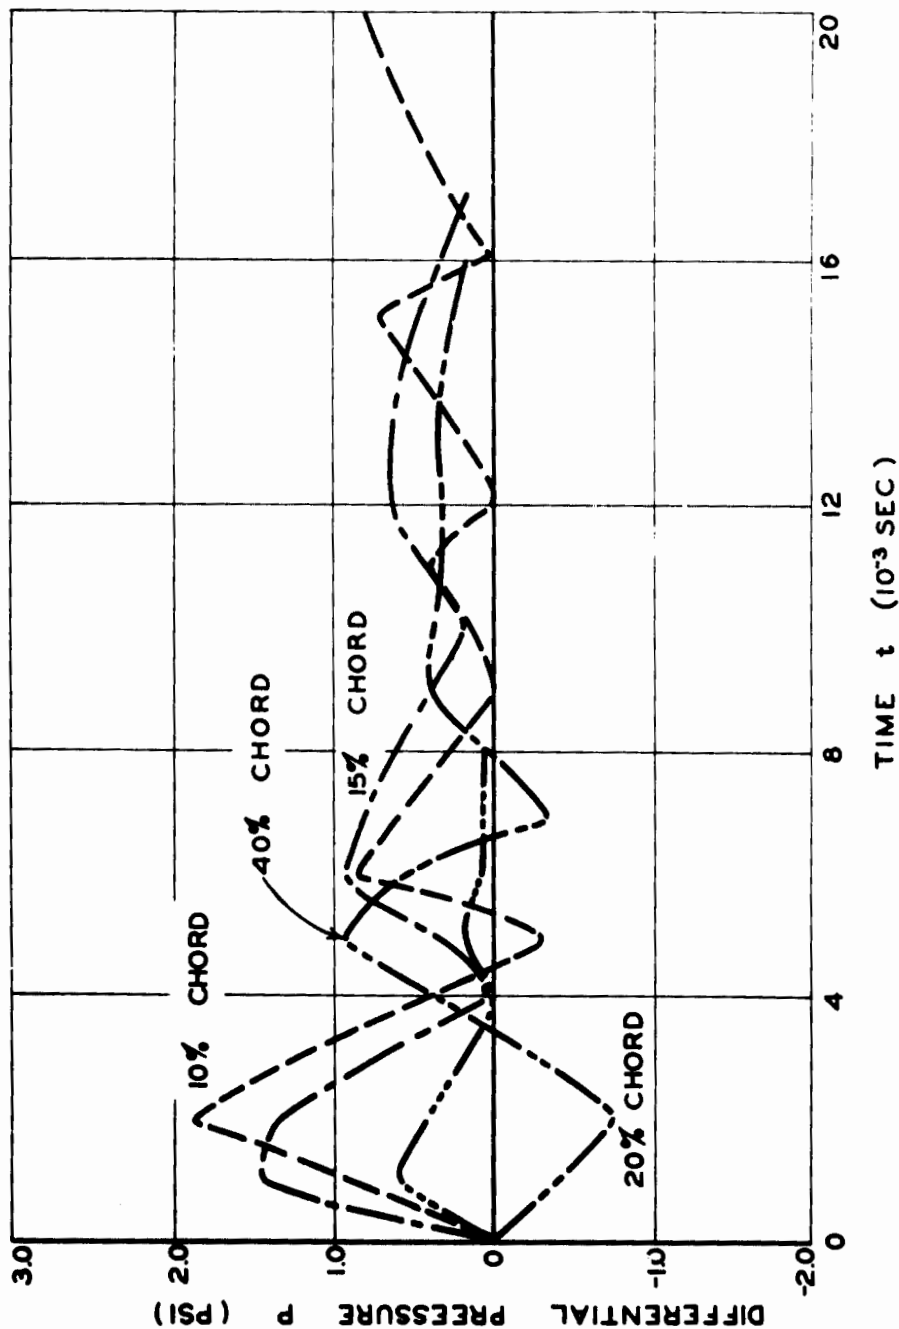
Fig. 5.31 Comparison during Initial Stages of the Variation of Differential Pressure at Four Chord Points of Rigid Wing 202. The angle of Incidence was  $9^\circ$ , and the range was 6,878 ft, Muzin.

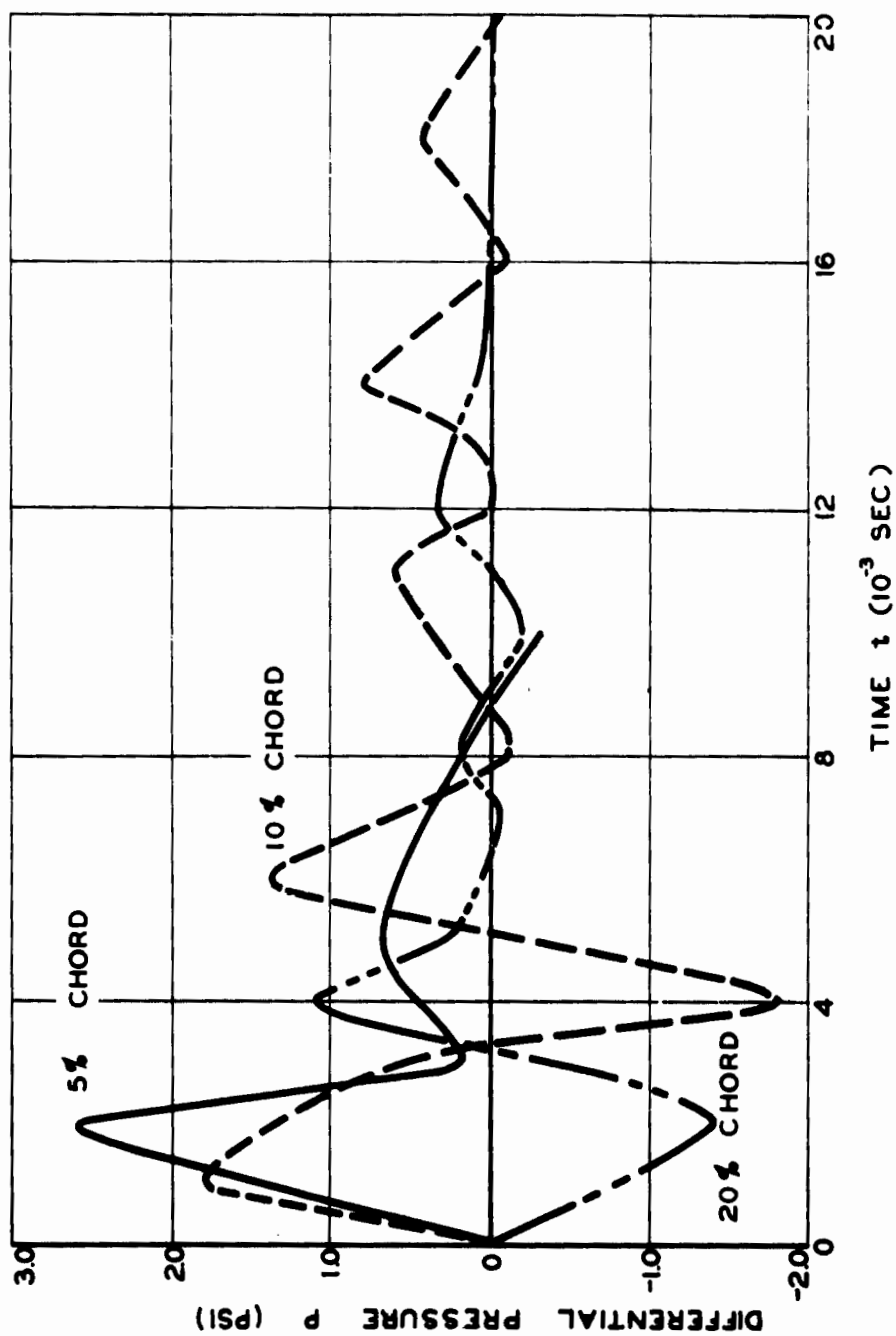
Fig. 5.32 Comparison during the Initial Stages of the Variation of Differential Pressure at Three Chord Points of Rigid Wing 203. The angle of Incidence was  $6^\circ$ , and the range was 6,878 ft, Muzin.

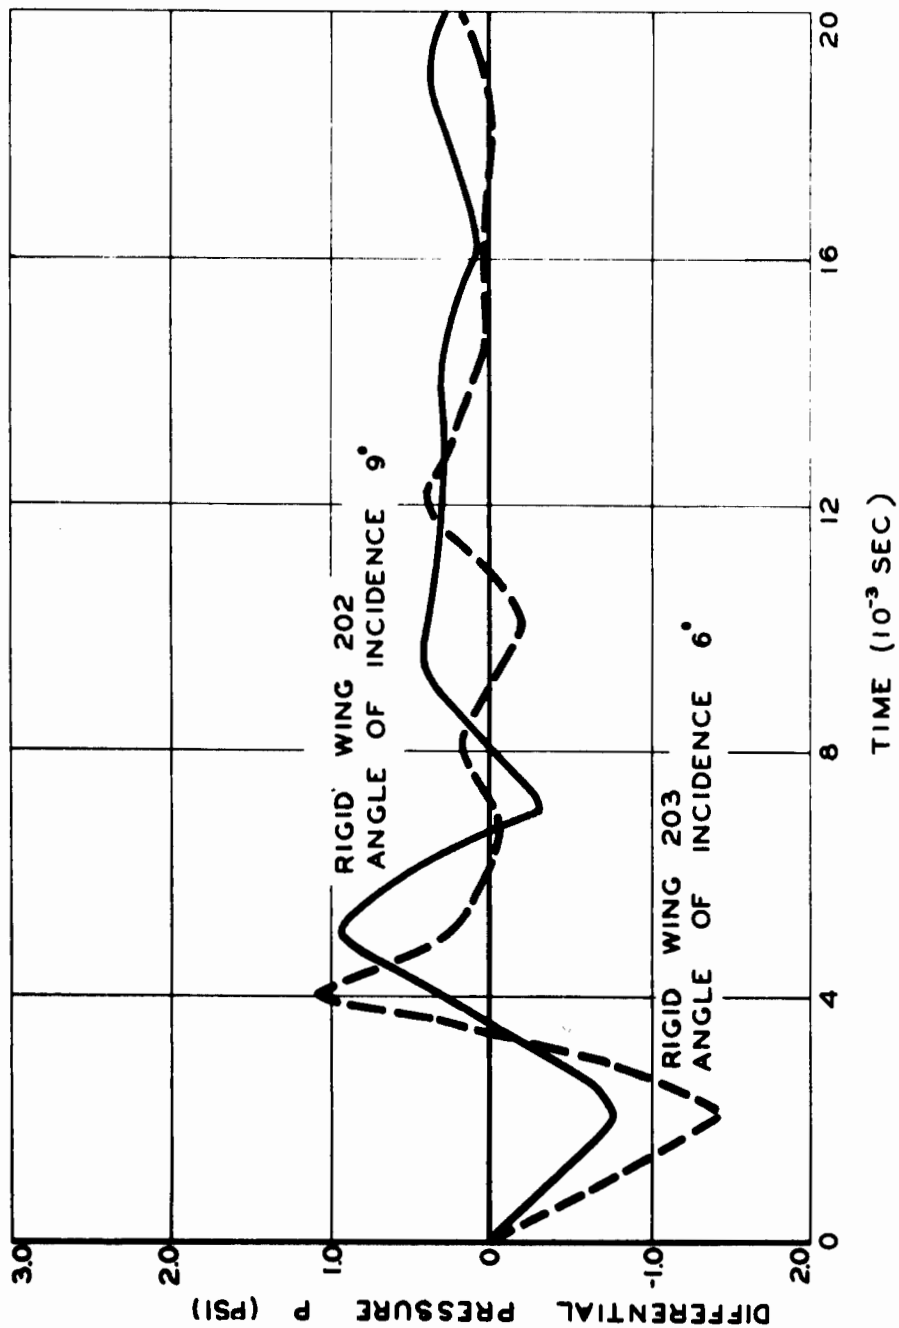
Fig. 5.33 Variation of Differential Pressure at 20 Per Cent Chord of Two Rigid Wings at Different Angles of Incidence. The range was 6,878 ft, Muzin.

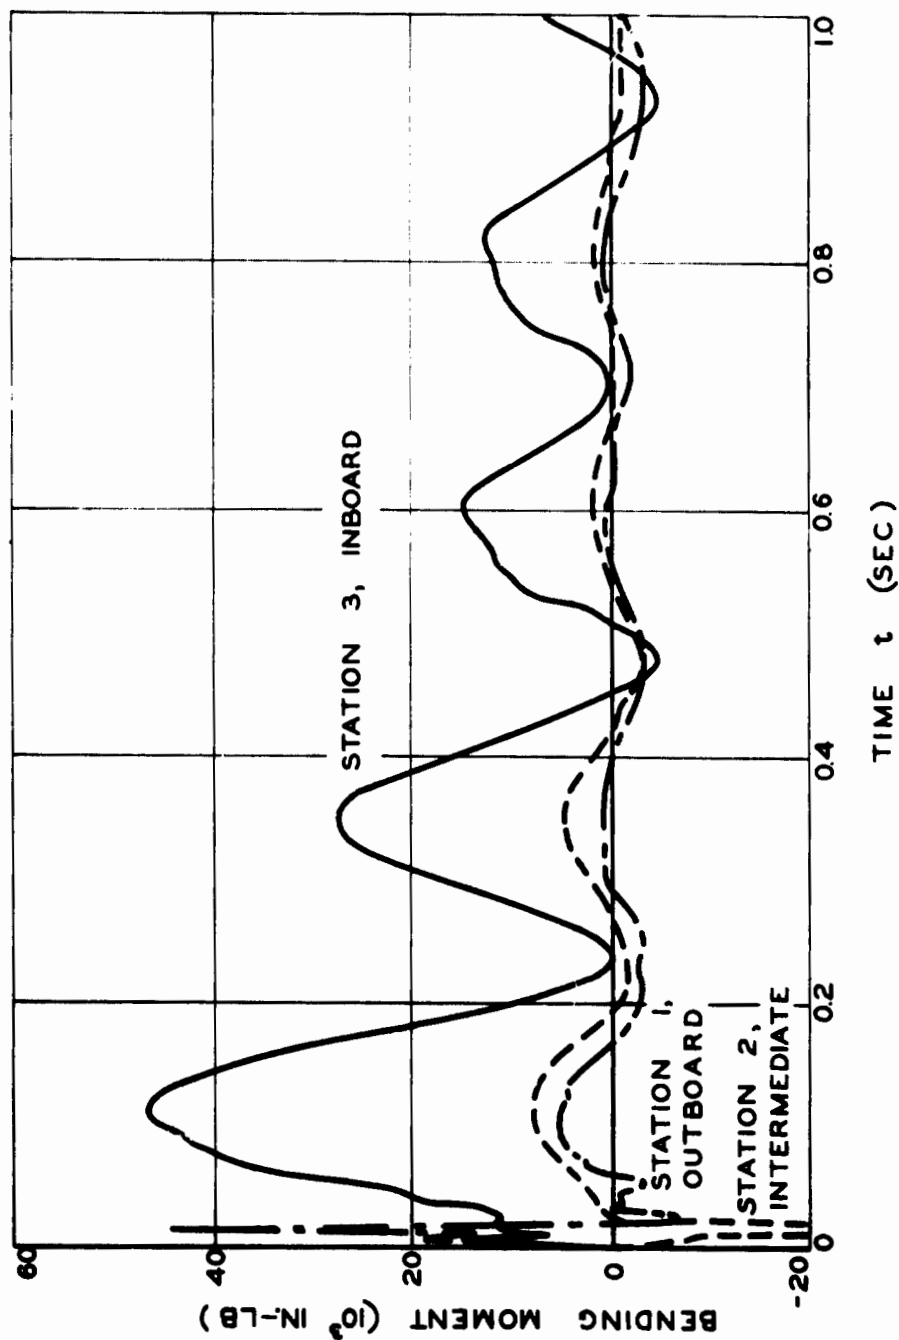
Fig. 5.34 Comparison of the Variation of Bending Moment with Time at Three Stations of Structural Wing 101. The angle of incidence was  $6^\circ$ , and the range was 4,020 ft, Engbeli.

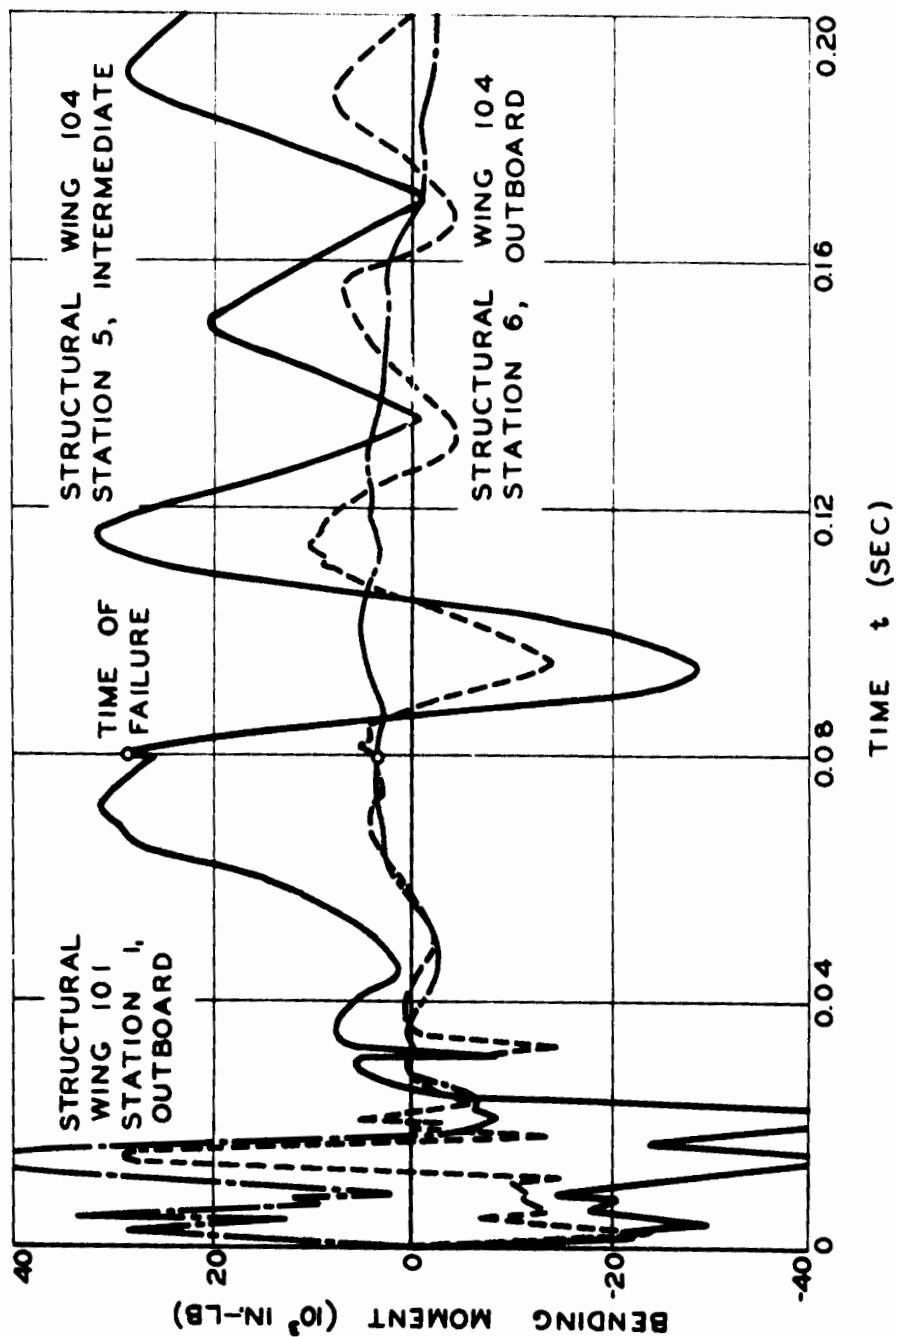
Fig. 5.36 Variation of Bending Moment with Time at Two Stations of Structural Wing 104, Angle of Incidence  $9^\circ$ , Compared with Bending Moment at One Station of Structural Wing 101, Angle of Incidence  $6^\circ$ , to Indicate Time of Failure of Wing 104. The range was 4,020 ft, Engcb.

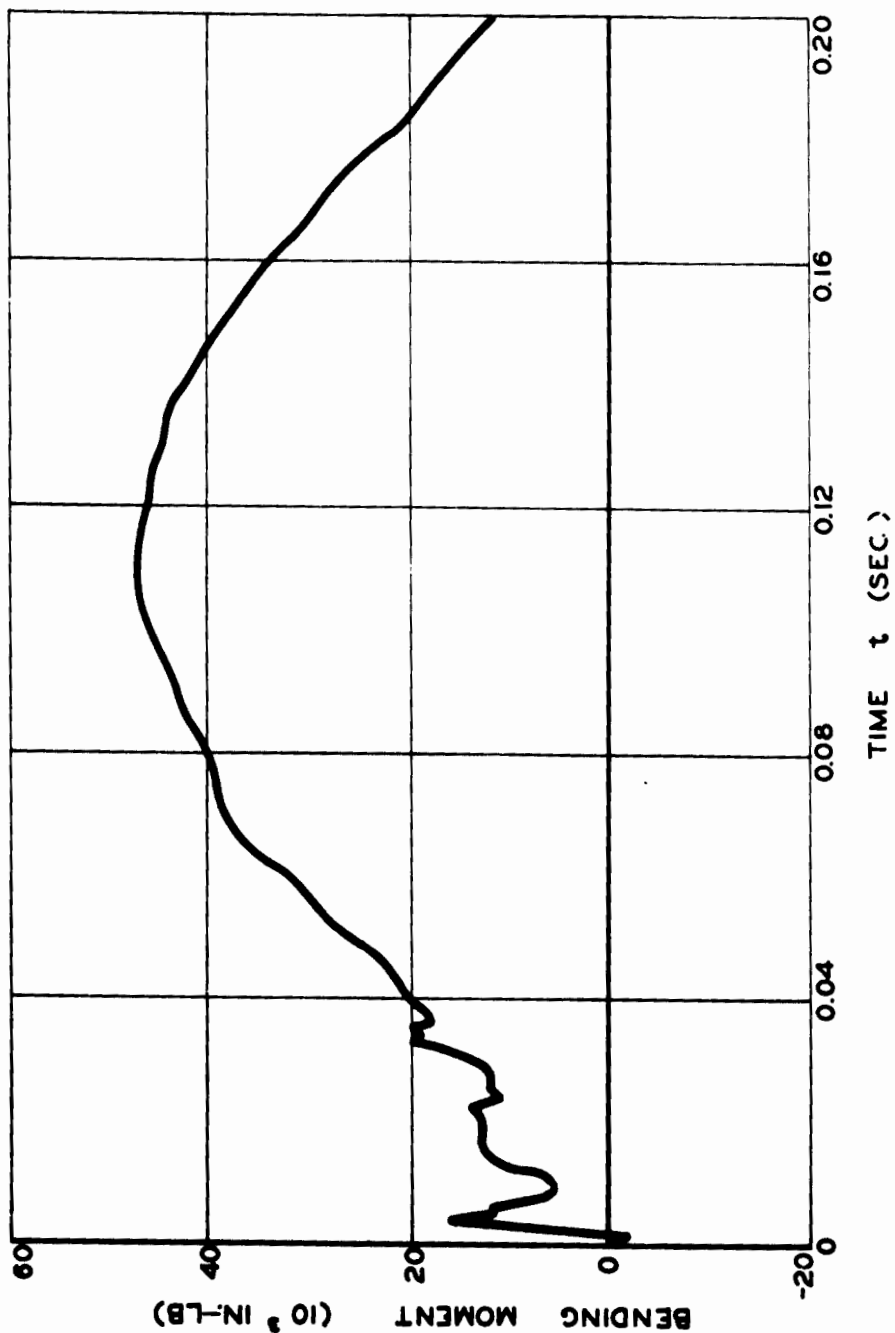
Fig. 5.37 Variation of Bending Moment with Time at Station 3, Inboard, of Structural Wing 101. The angle of incidence was  $6^\circ$ , and the range was 4,020 ft, Engbl.

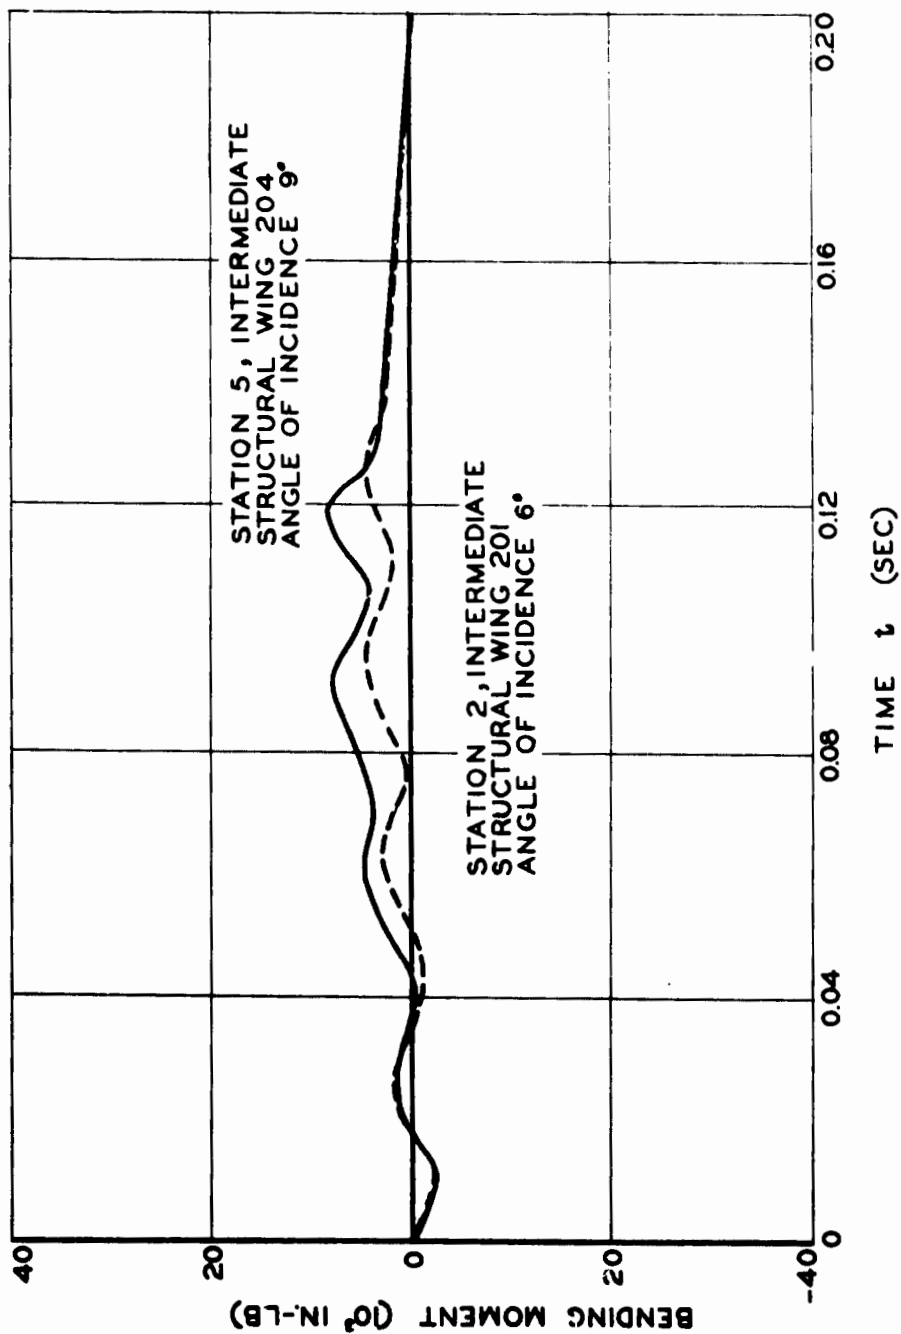
Fig. 5.39 Indication of Second-mode Bending Moment at the Intermediate Station of Two Structural Wings. The range was 6,878 ft, Muzn.

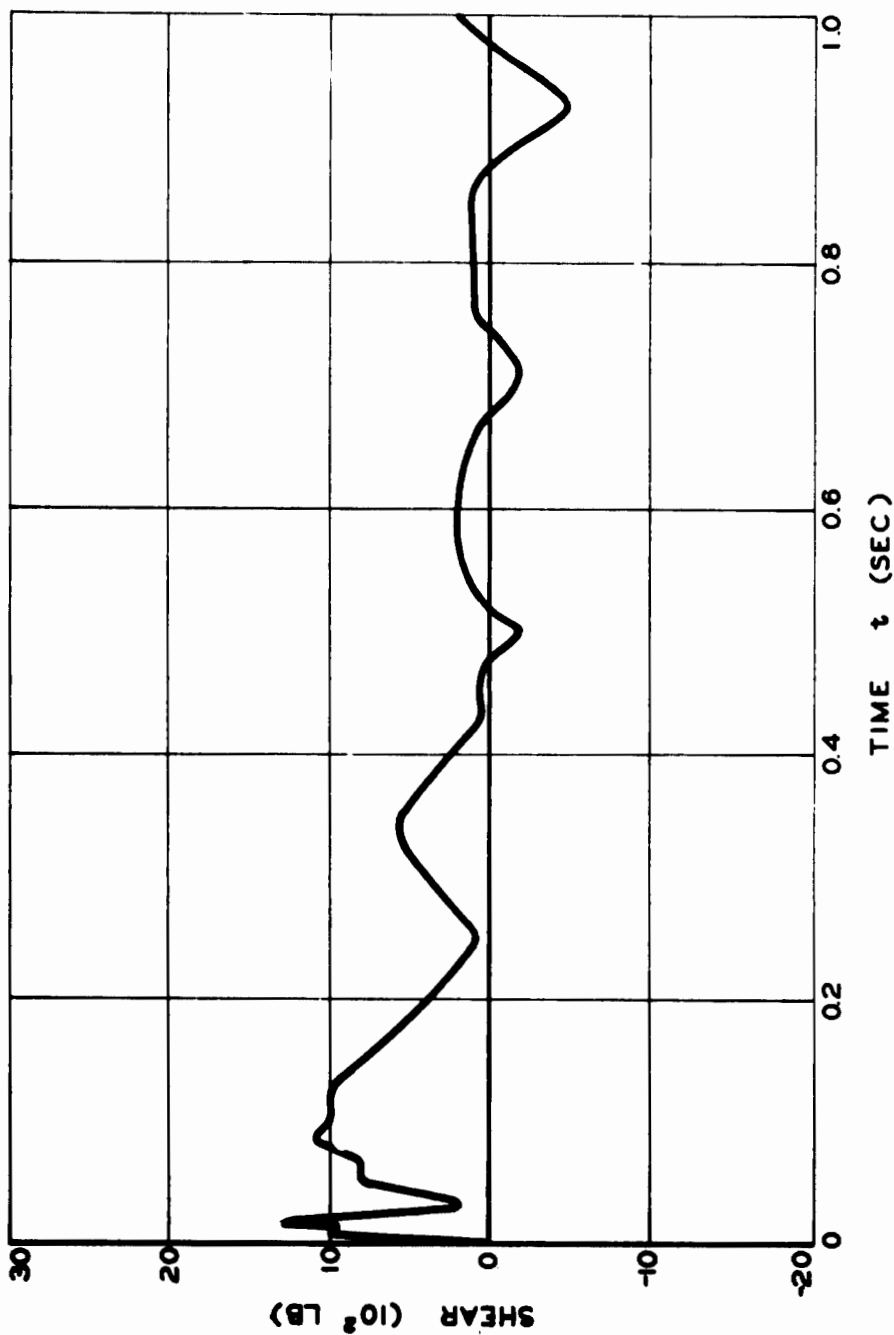
Fig. 5.41 Variation of Shear with Time at Station 3, Inboard, of Structural Wing 101. The angle of incidence was  $6^\circ$ , and the range was 4,020 ft, Engbbi.

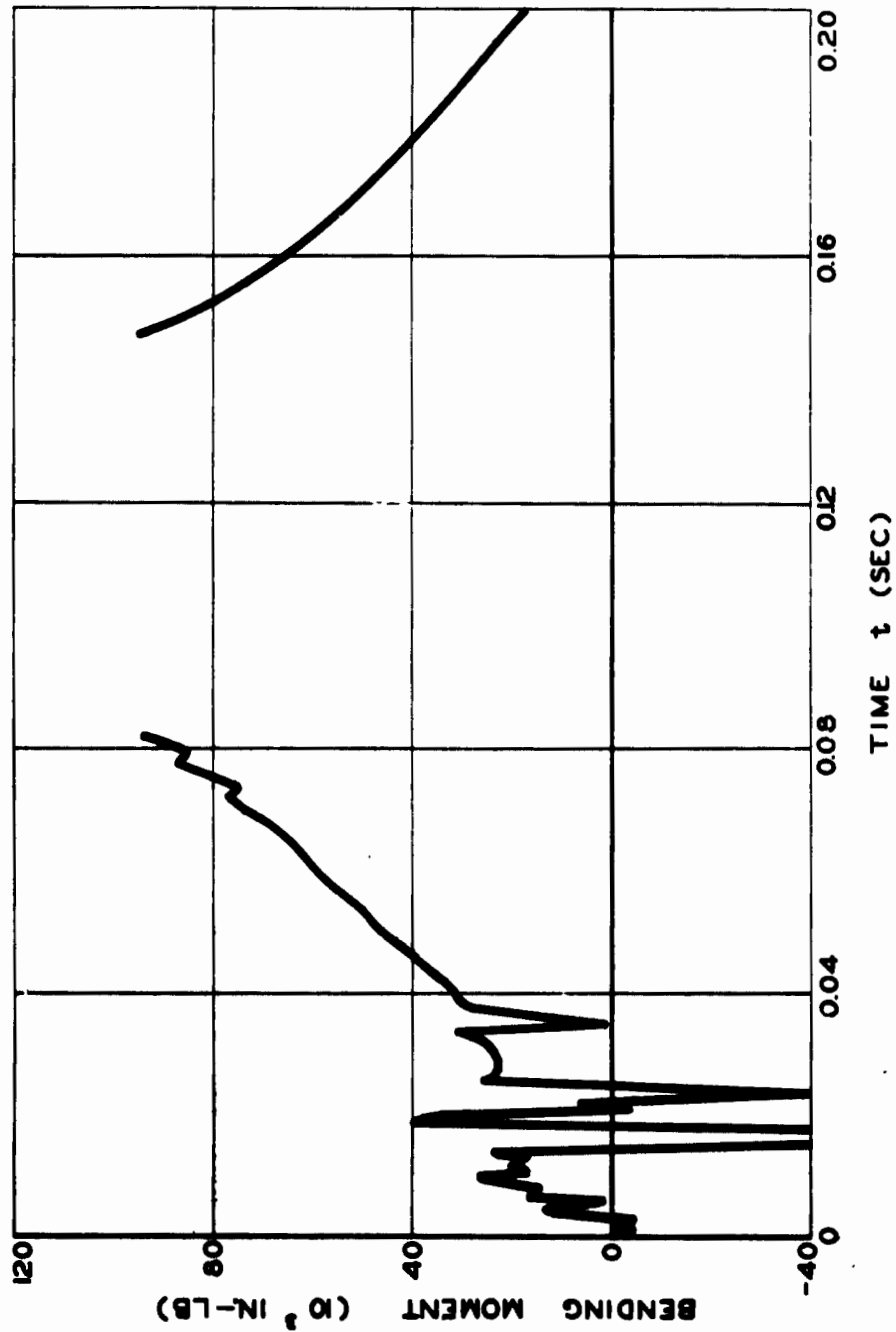
Fig. 5.42 Variation of Bending Moment with Time at Station 7, Inboard, of Swept Wing 105. The angle of incidence was  $8\frac{1}{4}^\circ$ , and the range was 4,020 ft, Engabl.

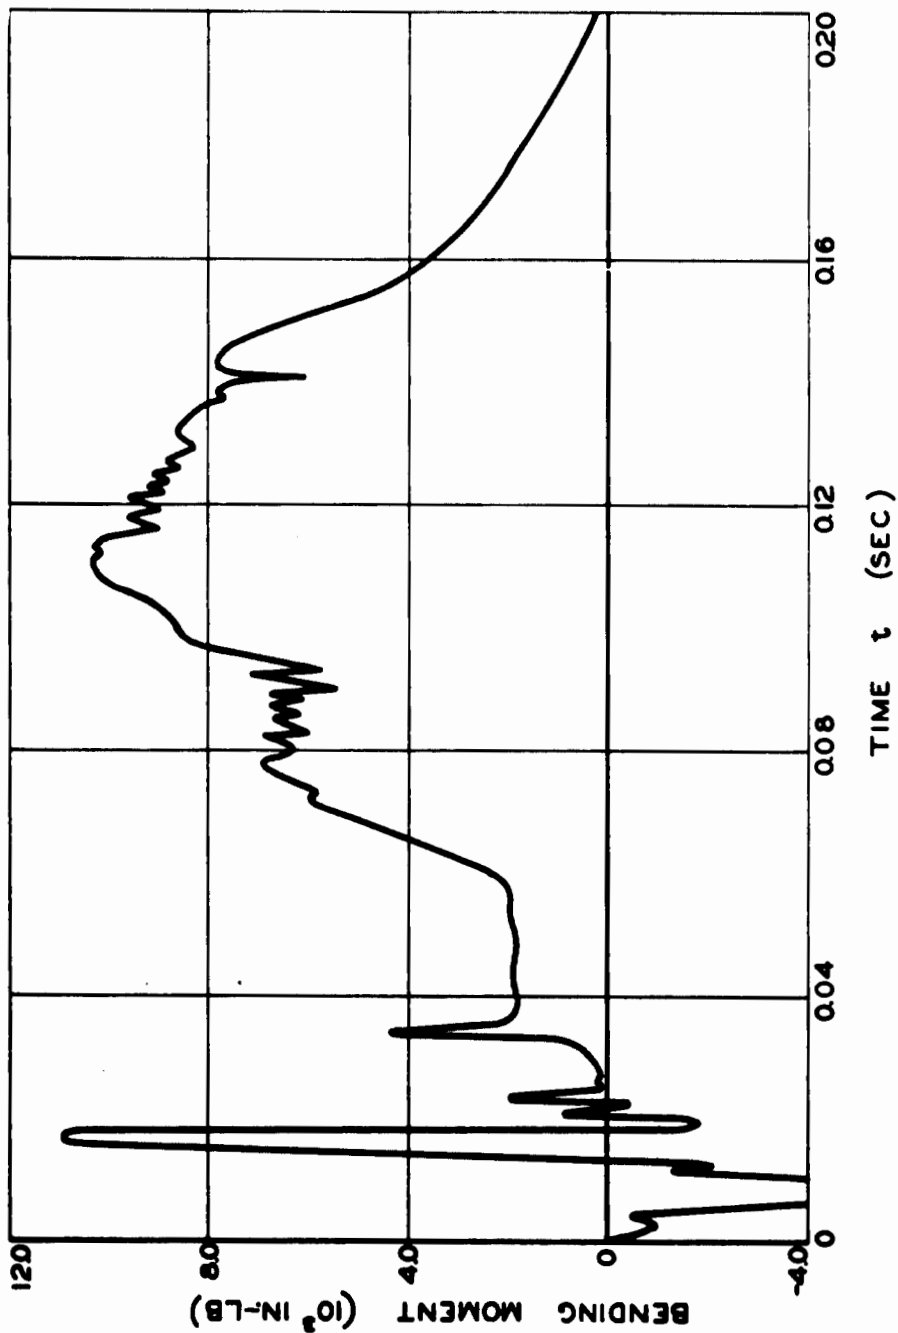
Fig. E.43 Variation of Bending Moment with Time at Station 8, Intermediate, of Swept Wing 105. The angle of incidence was  $8\frac{1}{4}^\circ$  and the range was 1,020 ft, Engel.

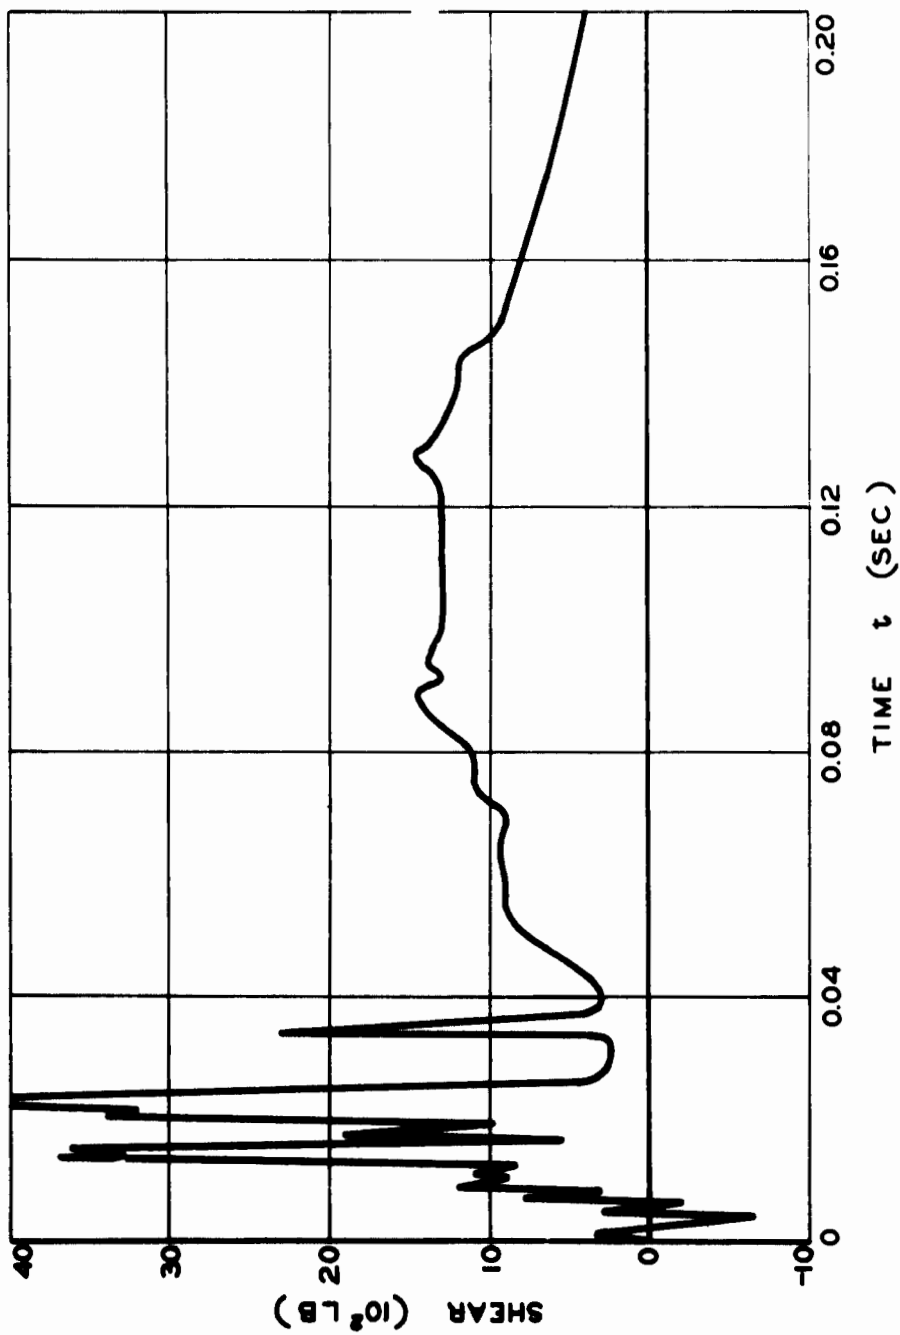
Fig. 5.45 Variation of Shear with Time at Station 8, Intermediate, of Swept Wing 105. The angle of incidence was  $8\frac{3}{4}^\circ$ , and the range was 4,020 ft, Engbl.

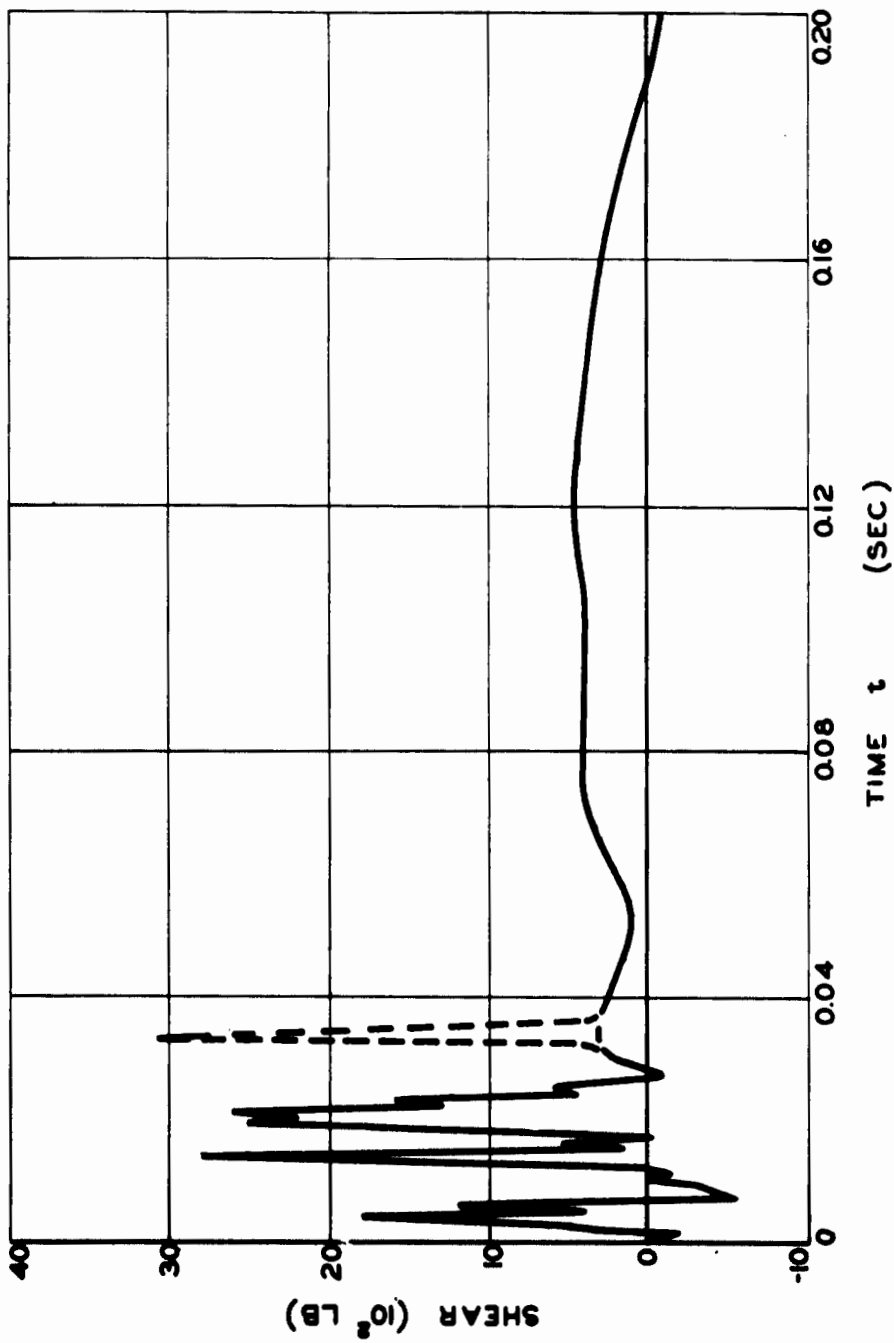
Fig. 5.46 Variation of Shear with Time at Station 9, Outboard, of Sweep Wing 105. The angle of incidence was  $8\frac{3}{4}^\circ$ , and the range was 4,020 ft, Engbl.

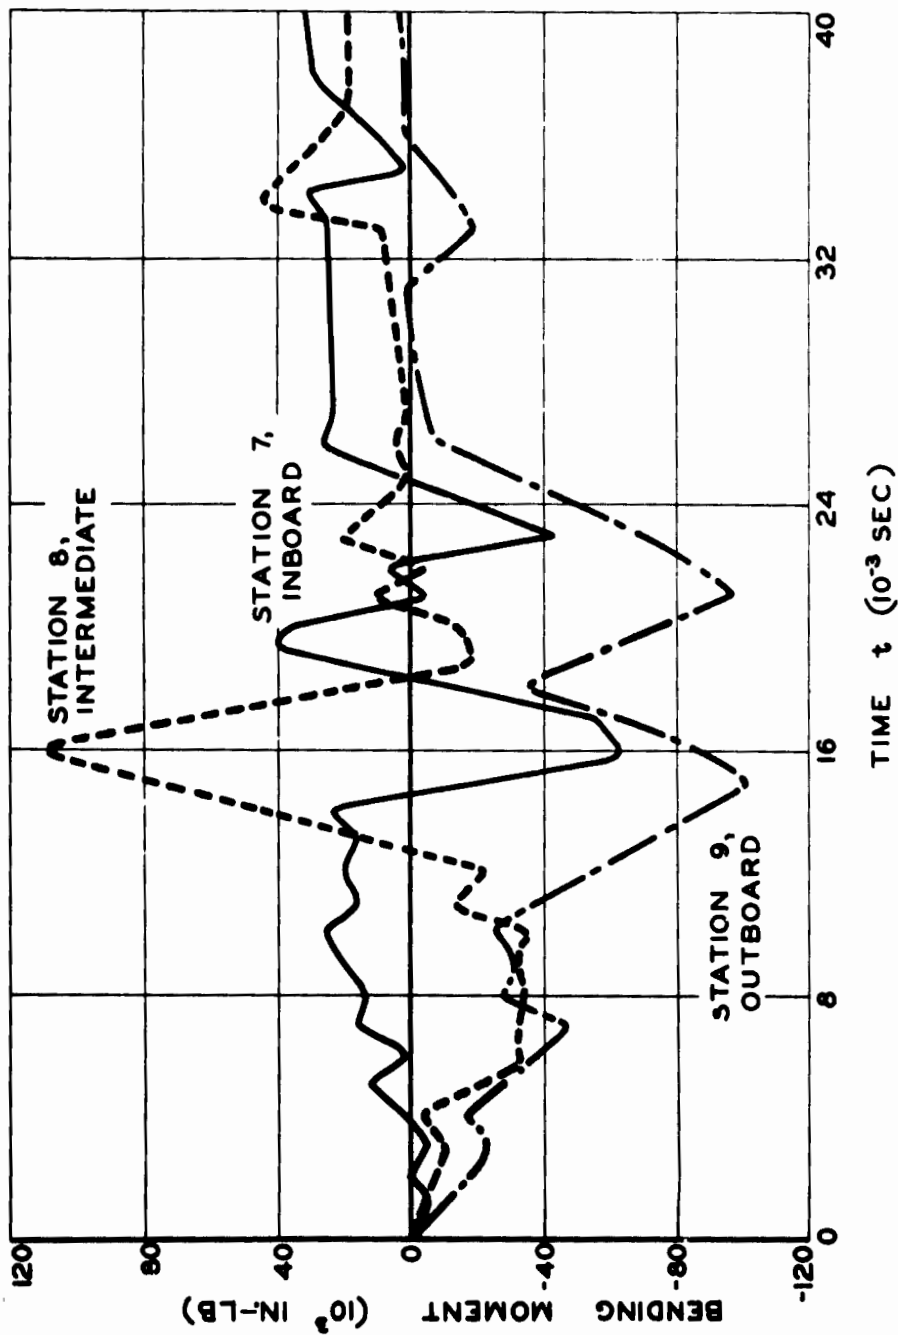
Fig. 5.47 Comparison during Initial Impulse of the Variation of Bending Moment with Time at Three Stations of Swept Wing 105. The angle of incidence was  $8\frac{1}{4}^\circ$ , and the range was 4,020 ft, Engebli.

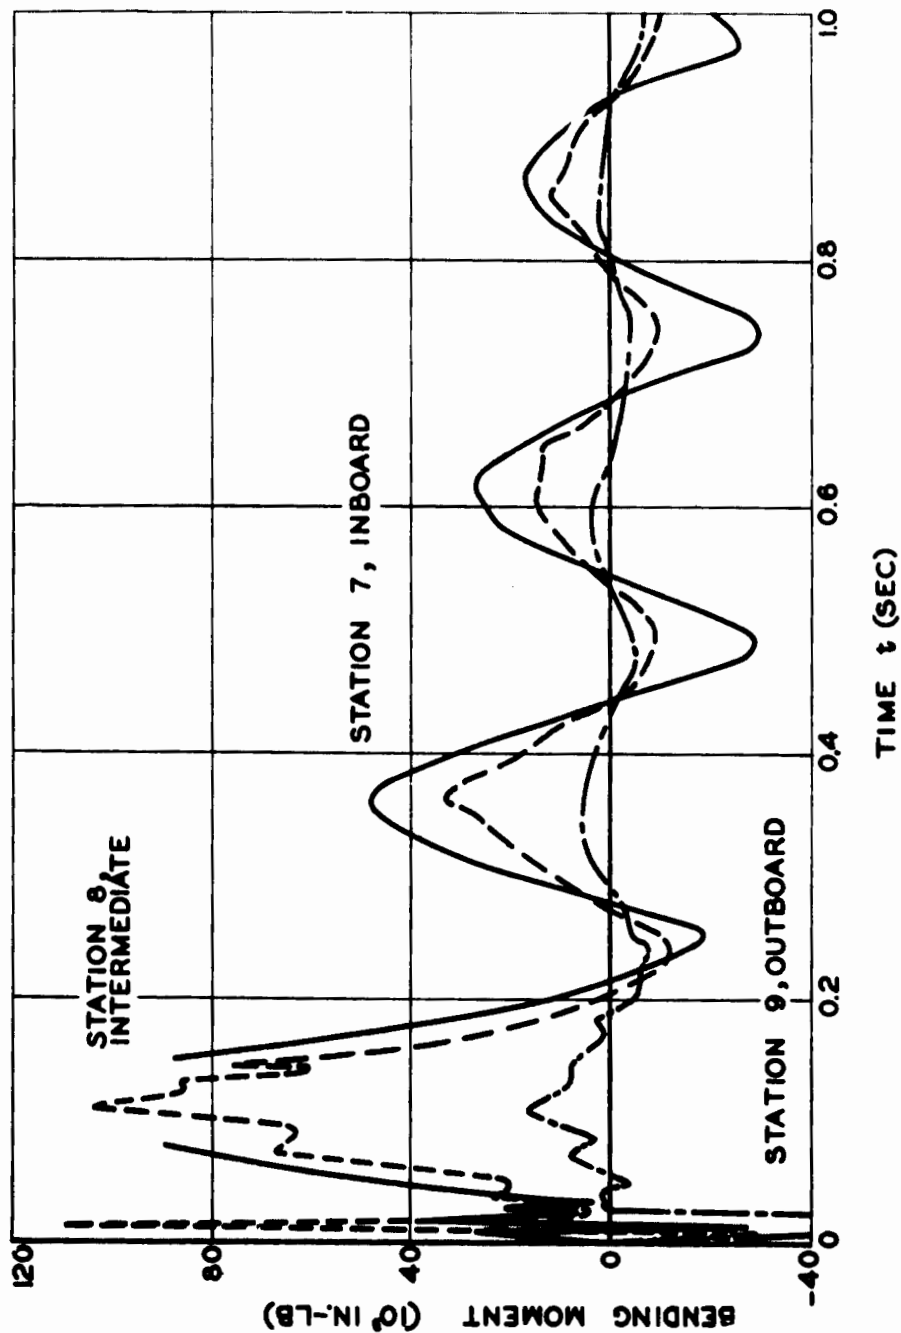
Fig. 5.48 Comparison of the Variation of Bending Moment with Time at Three Stations of Swept Wing 105. The angle of incidence was  $8^\circ 4'$ , and the range was 4,020 ft, Engbl.

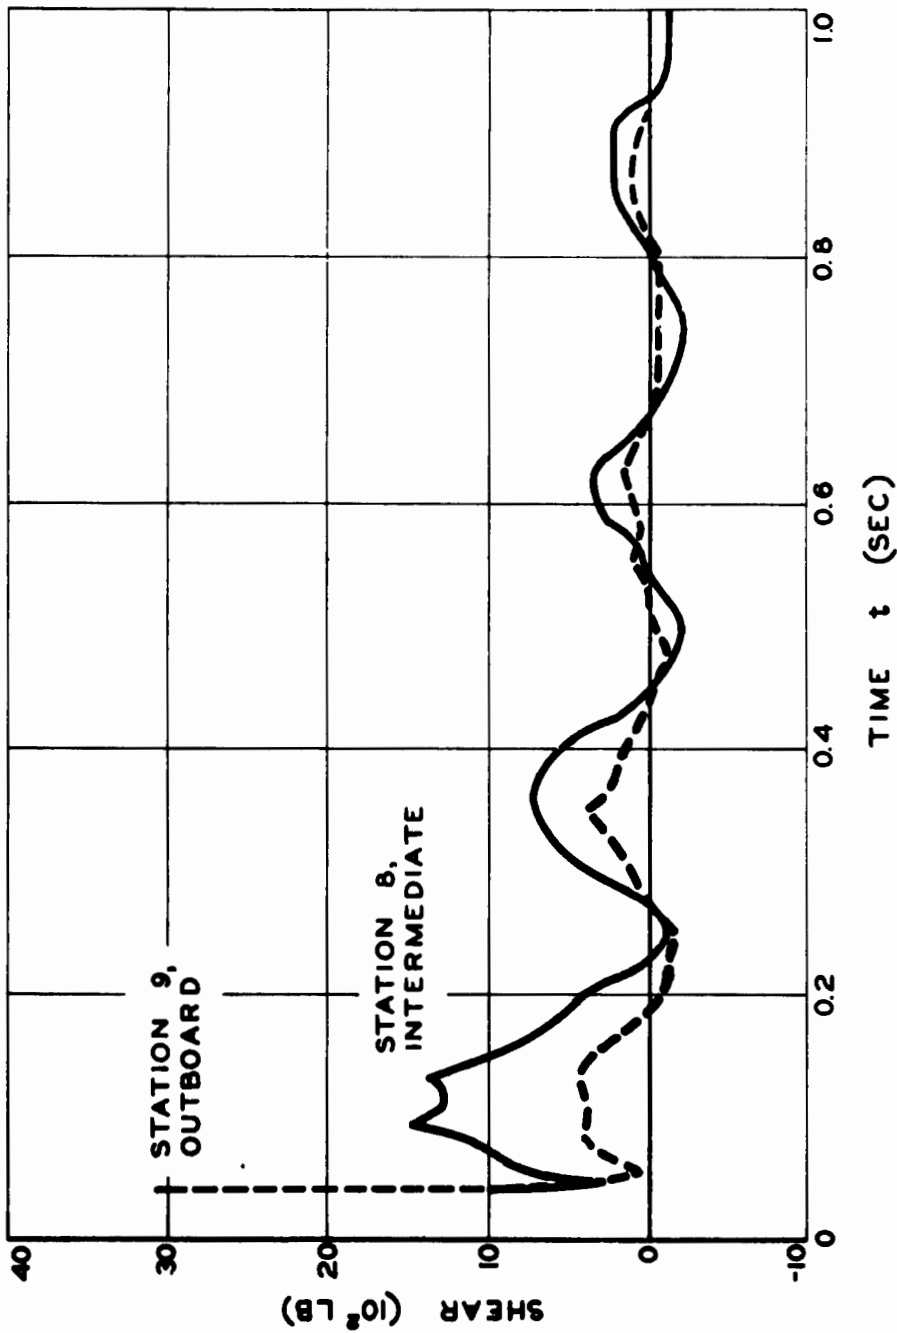
Fig. 5.49 Comparison of the Variation of Shear with Time at Two Stations of Sweep: Wing 105. The angle of incidence was  $8\frac{1}{4}^\circ$ , and the range was 4,020 ft, Engabl.
